**NAME & DESCRIPTION OF PROPOSAL:** Luthy Bulkhead Repair

Approval to reset rocks and material to repair the existing shoreline bulkhead and retain existing vegetation along Lake Washington.

**Luthy Bulkhead Repair**  
**File Number: 12-124689-WE**

PROPOSED: REPAIR EXISTING ROCK BULKHEAD

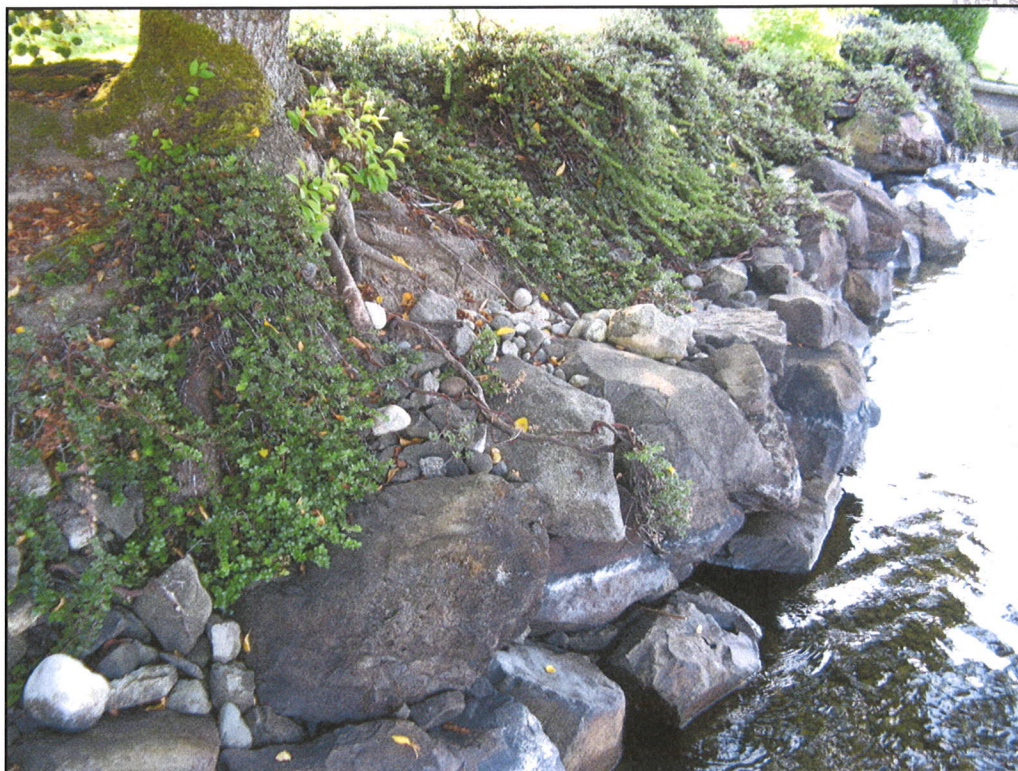
Directly south of the pier: This photo shows exposed roots from the tree and nearshore shrubs and crushed rock backfill about to fall into the lake.

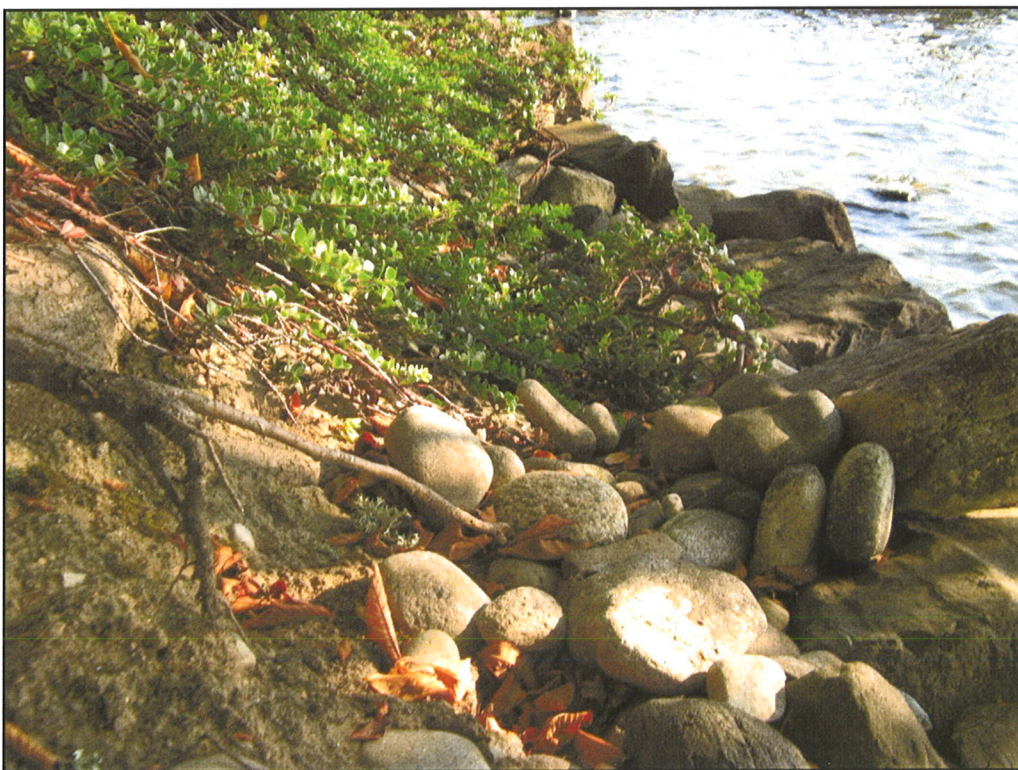
Another angle of the same area taken at a different time of day. Note the exposed roots and uncovered crushed rock backfill.

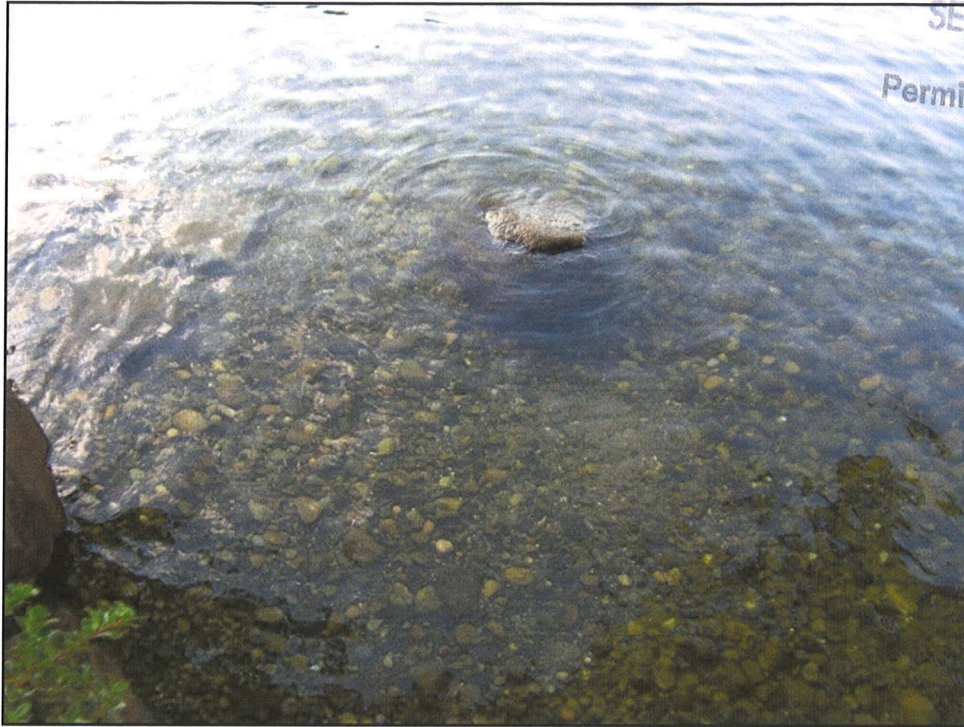
In front of the large tree: Several of the fallen bulkhead rocks to be reset. There are two others to the left of the one in the middle of the photo.

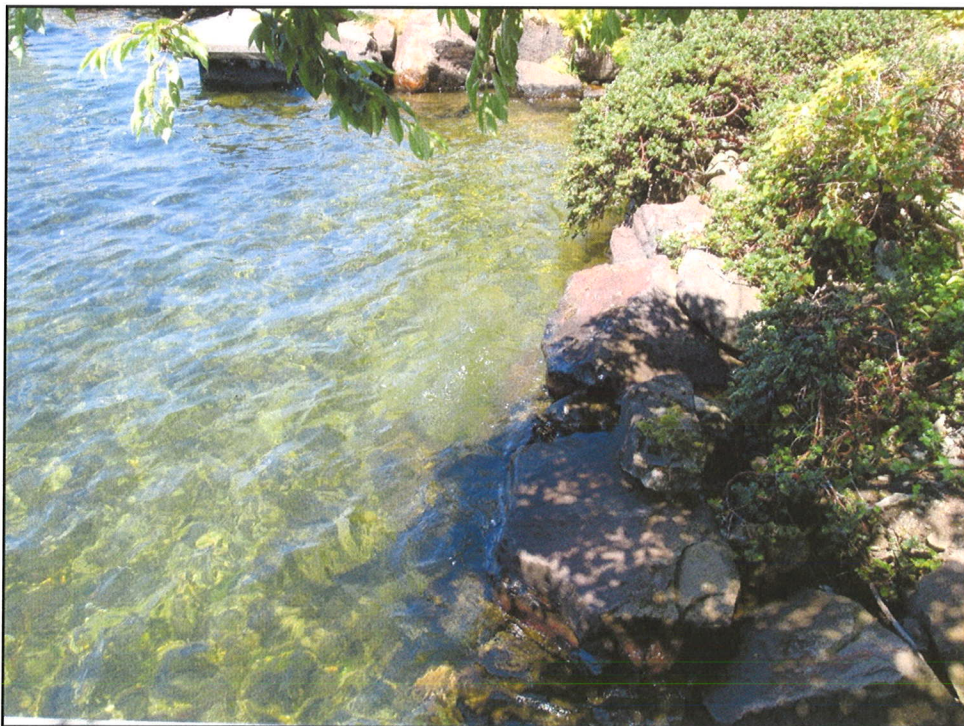
Directly north of the pier: More exposed shrub roots and uncovered crushed rock backfill. There are rocks in the water but are difficult to see. Sinkholes have developed in this area due to the top rocks falling in and wave action coming over the top.

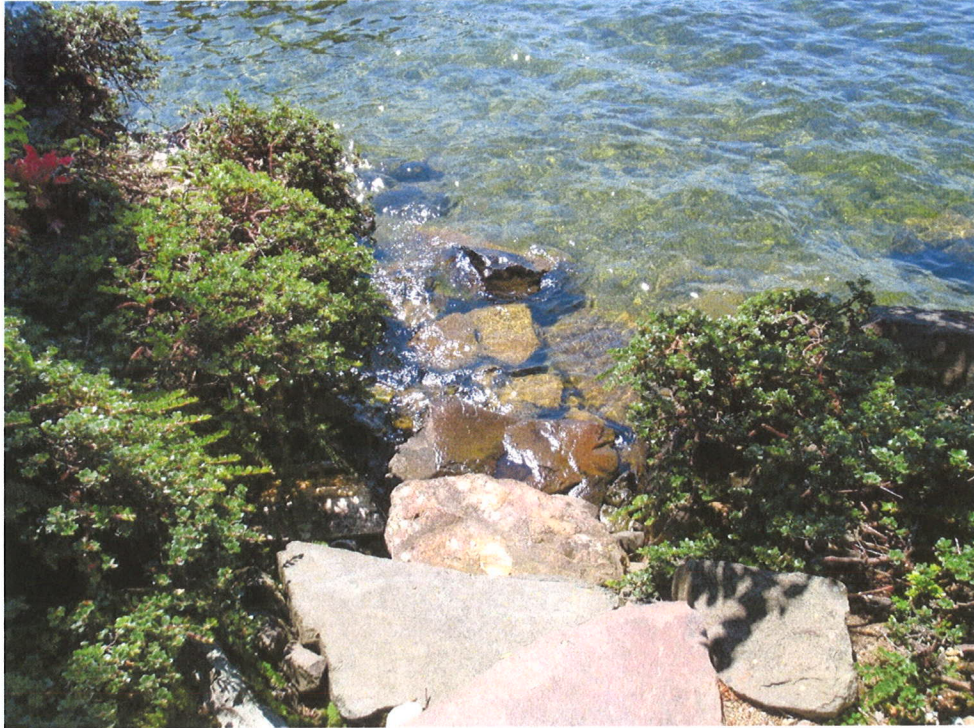
Rock stairs into water: You can see the last step before the water is crooked and the others in the lake are completely uneven.

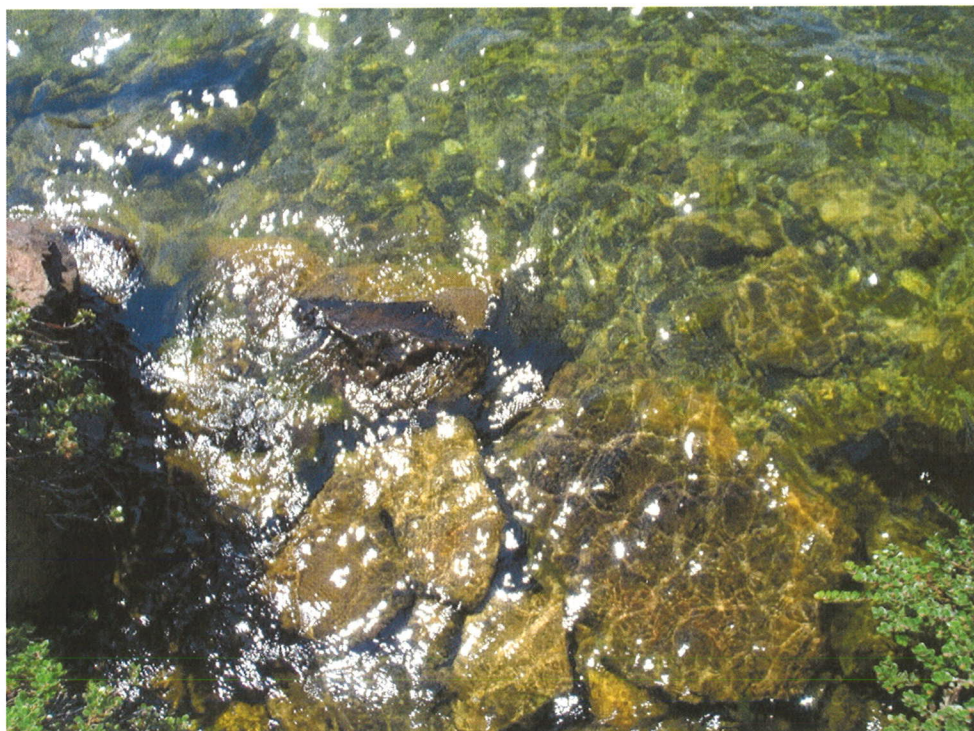
Another view of the rocks at the bottom of the stairs: These are not safe for walking on. Also note the other larger rocks in the water that have fallen from the bulkhead.
